Post-Remedial Action Report
Area 4,4A, and 4B

Figure 4.3-1
Summary of Contamination and Remedial Results

Linde Site, Tonawanda, New York

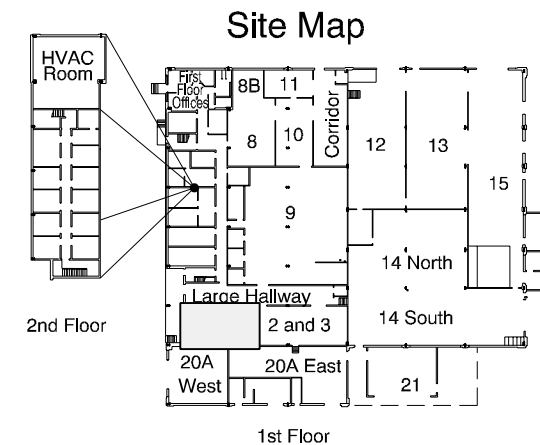
- LEGEND**
- Building Walls
 - Grid Coordinates (1 meter x 1 meter cells)
 - Soil boring location
 - Contamination less than 1 meter on walls
 - Contamination up to 1 meter on walls
 - Surficial floor contamination
